Report No. 8926-159

Material - Magnesium - AZ91 Casting

Evaluation of Non-Destructive Inspection Procedures

REPORT NO. 56-216
SPEED-BRAKE CASTING. 8-73673EVALUATION OF

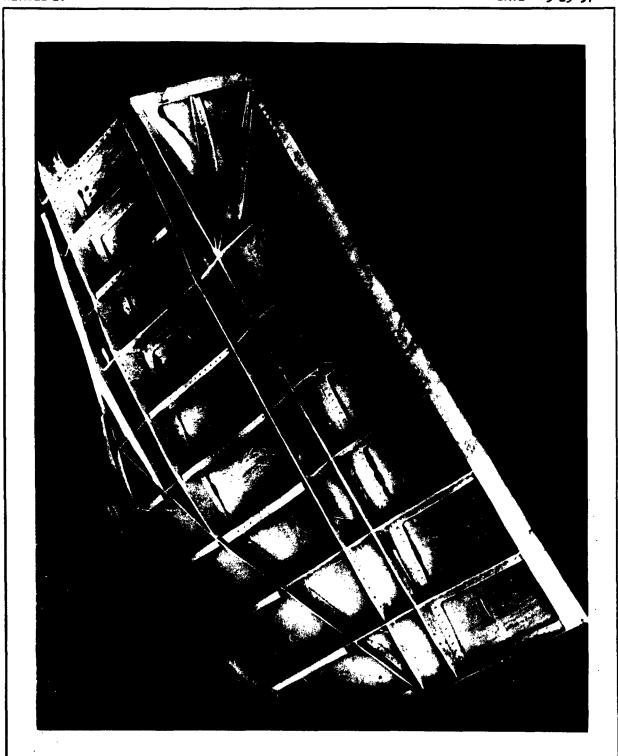
FIGURE 4. COUPONS 1, 3, 4, & 5. (SHOWING DYE INDICATIONS)

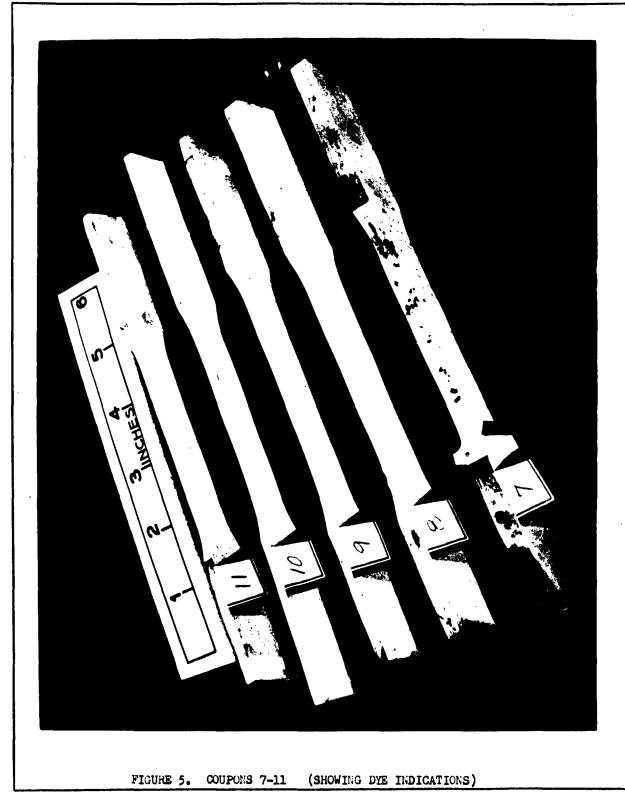
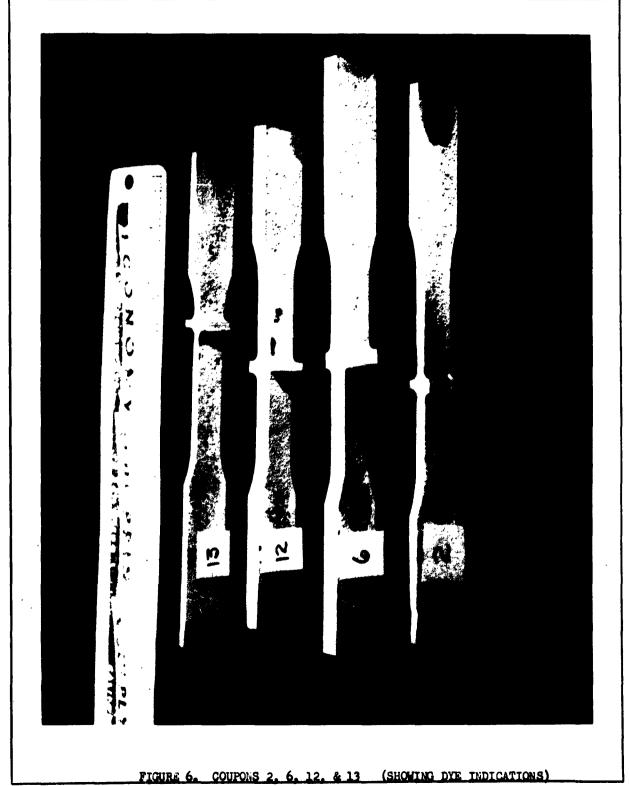
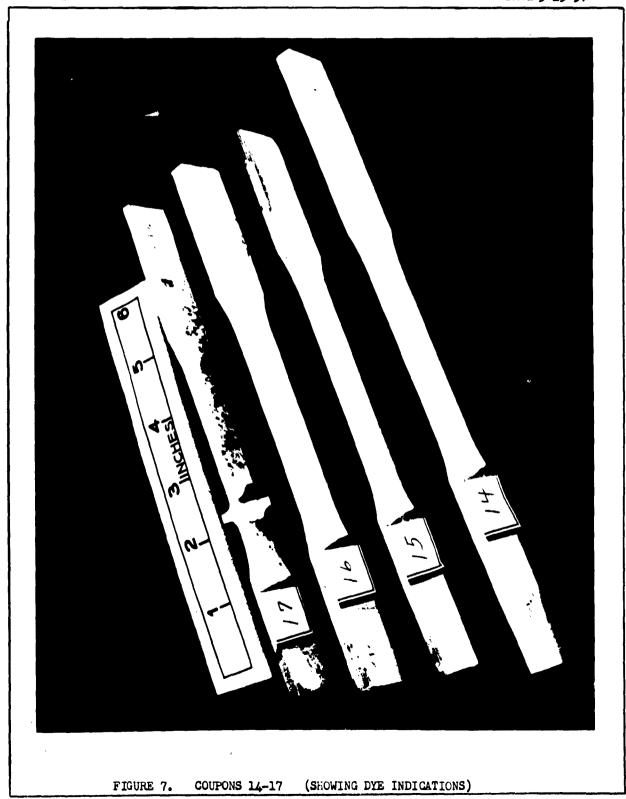
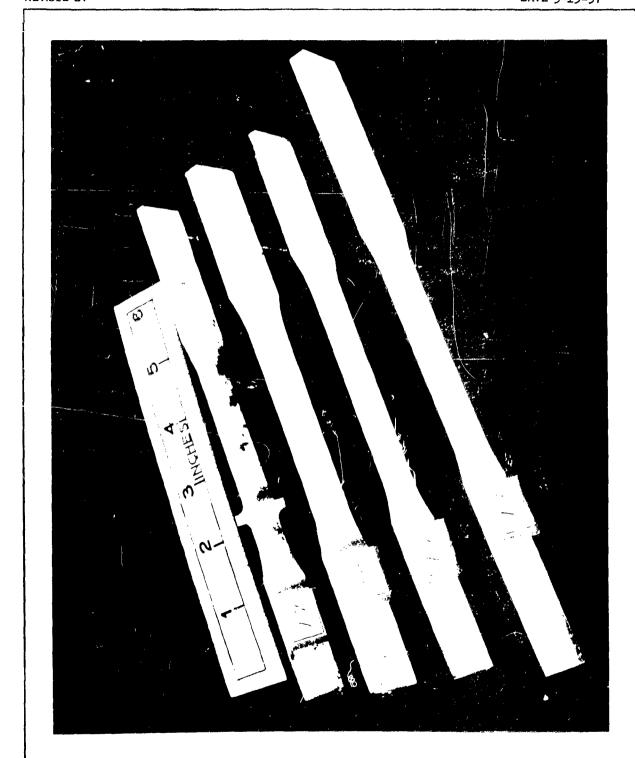
The samples were then inspected and rated by the Process Control Department. The dye-penetrant method requires approval or rejection by an experienced inspector. Thotographs of all of the coupons are shown in Figures 4 through 10; the pictures were taken shortly after the dye-penetrant examination and with the developer coating still intact.
